## Johnson QD Coils

### Article & Photo's By Peter McDowell

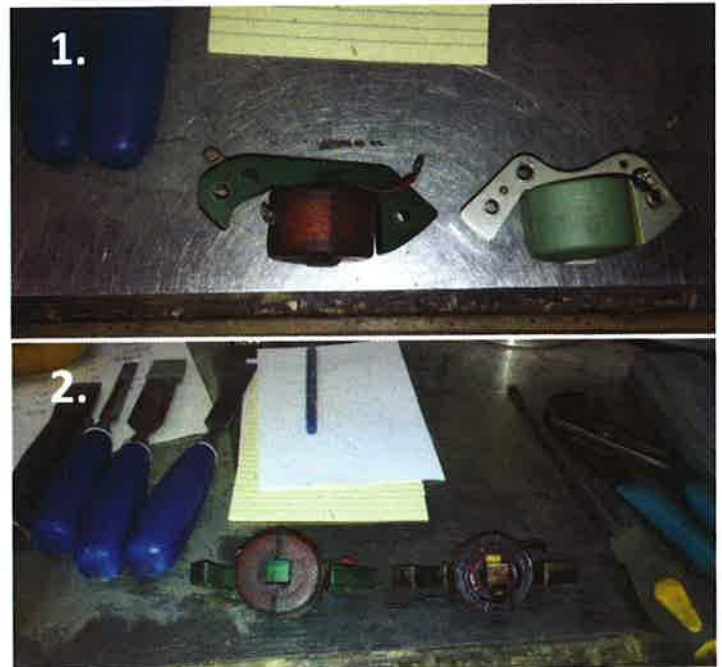
The 1949-1950 coil is NLA and very difficult to come by used or NOS, firstly because of its age, it was only used on a few motors for two years, and secondly because the material used to encapsulate the coil degrades with age. It becomes semi-liquid at room temperature.

**Picture #2** shows two of the old coils side by side. The one on the left is in very good condition. The one on the right is how most of them look. You will find the majority of these motors with sticky brown goo dripped down the cowl, front, back or sides depending on which position it was left in. I believe it is a combination of age and heat because I have seen a very few NOS coils where the material had not degraded, so it can't be just age.
