Gearcase Bushing Repairs

Article & Photo's by : Peter McDowell

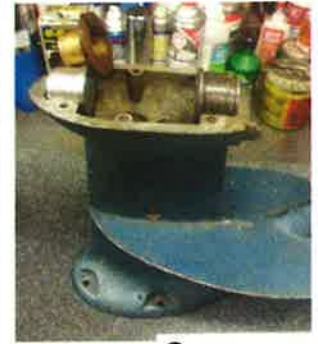
1.

The upper bushing is relatively easy to repair (see picture #1) because of the machined surface for the oil seal which is concentric with bushing. So even if the bushing is damaged you can find the original center spot by taking a reading off of the machined surface for the oil seal. Then bore out a larger hole and press in a new bushing. Fairly straight forward. One additional wrinkle is that the new bushings come without oiling holes and grooves, these have to be cut in manually.

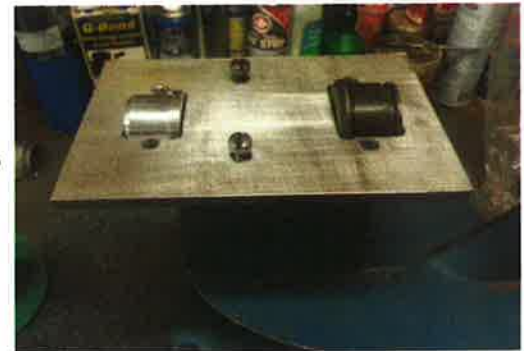
3.

The lower bushing is not so simple because there is nothing concentric to the original hole and since the bushing is worn you can't line up with that surface. I thought about it for a while and this is what I came up with. I would make a jig out of aluminum that is concentric with the original hole. Since the original rear bushing is aluminum with a bronze core I can use it as is. The original front bushing is solid bronze so I made a replica out of aluminum on my lathe. (see picture #2) I cut out a plate of 1/4" aluminum and on the milling machine drilled out bolt holes to match the pattern on the gearcase. Then I machines out two holes to fit over the bushings. (see picture #3) Then I clamped everything together (see picture #4)and welded the bushings to the plate. (see picture #5)

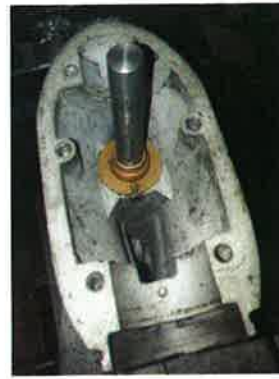
6.

The next step is to remove the plate from the gearcase. I then took a damaged driveshaft and cut it down so it was just longer than the height of the gearcase. In my drawer of bushings I found two that fit together over the shaft equal to the size of the pinion gear, I had to take a couple of thousandths off of the OD of the outside bushing to make it fit. I then inserted the driveshaft into the gearcase and slid the bushings over the shaft to take the place of the pinion gear. (see picture #6) This had to be a gearcase where both bushings were in good condition. Of the 5 gearcases I have, only one had two good bushings. This holds the driveshaft in the proper position centered on the holes for both bushings.

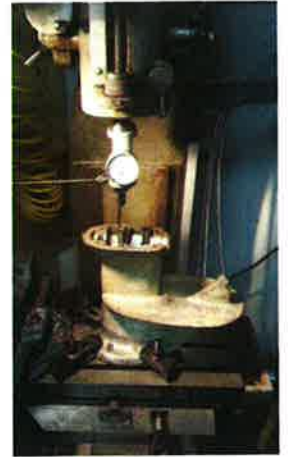
7.

Now I can clamp the gearcase to the milling machine table & center it on the protruding shaft. (see picture #7) . Then lower the table, remove the shaft and bolt the plate with the bushings back on the gearcase. I put a milling bit in the machine cut a hole in the plate which will be concentric with the bushing hole. (see picture #8) Then on the lathe I made a piece about 1" in diameter with a step on it the size of the hole and welded it in place. (see picture #9)

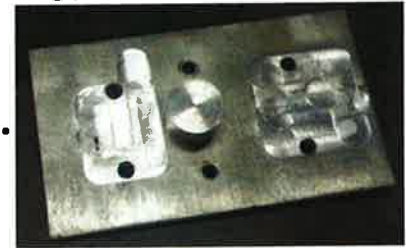
10.

Picture #10 is a top side view of the plate with the centering button in place and the top half of the bushings milled off. The top half is not needed, the bottom half is the part that is used to keep the plate in alignment. Picture #11 is a side view of the plate. Picture #12 shows the plate clamped in place on a gearcase. So now when a gearcase comes in with a bad lower bushing. I can bolt the plate to the gearcase, center it under the mill, remove the plate and bore out the old damaged bushing.
