When the "Right Stuff" is the "Wrong Stuff"

Report & Photo's: Ron Stevenson

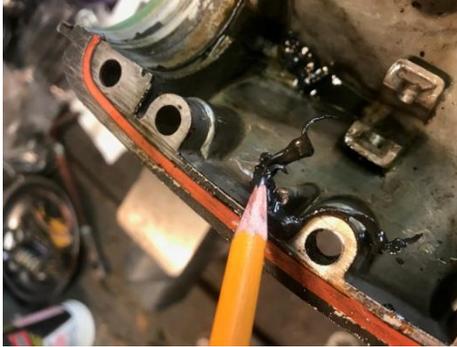
Excessive "Right Stuff" slopped all over the inside of the skag

I knew right away that someone had smeared the screws with black Permatex " RIGHT STUFF". This is the Wrong Stuff for lower units. This stuff is not designed to seal lower units. Whoever did this, smeared the Wrong Stuff all over. It was on the gear set and down in the skeg cavity.

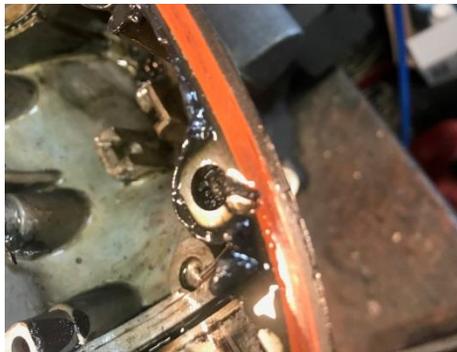
Orange silicon seal spread in the skag groove., The proper BUNA rubber cord seal was missing.

The other tragedy was that this same person tried to fill the skeg groove with Orange silicon seal. This sealant is no good for lower units at all. Silicon seals work great for sealing bathtubs...not outboard lower units.

The proper skeg seal is the special oil proof BUNA rubber seal...nicknamed the ' spaghetti' seal.

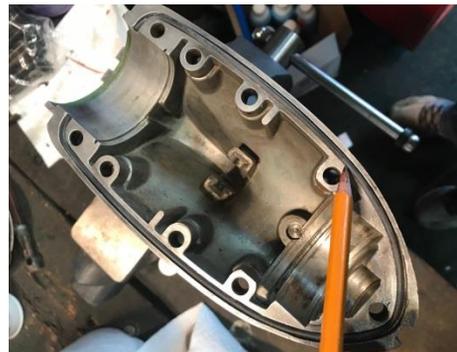
Skeg all cleaned, groove all cleaned, new Cord laid in groove & affixed with 3M, 847 adhesive

To properly hold the seal into the groove, you must thoroughly clean the skeg groove first. Then, cut the spaghetti cord to the proper length. Apply a thin line of 3M, 847 adhesive in the groove. Lay the spaghetti cord in the groove applying pressure with your fingertip along the cord to "wet-out" the cord. This guarantees the cord seal is seated in the groove. Once that's done place the skeg aside.

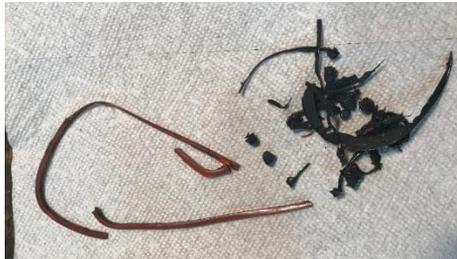
The garbage remnants of the black "Right Stuff" & the semi-cured Orange silicon seal that were removed from and around the skeg.

The person who thought that filling the threaded screw holes with 'Right Stuff' would stop leaks, was not thinking clearly. I had to take a dental pick and pry the hardened crap out of each individual threaded screw hole.
